Steam Boilers—Explosions.

STEAM BOILER EXPLOSIONS,

EDWARD BINDON MARTEN,

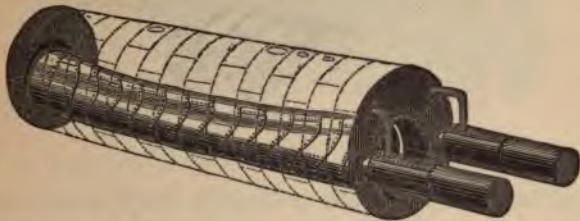
Fig. 5.

No. 6. Stoke. (Fig. 5.) February 6th. *none injured.*

One of three. One tube Cornish, with two external fire grates with a water tube over each fire. It was 30ft. 2in. long, 6ft. diameter. Tube 3ft. diameter, $\frac{3}{8}$ inch plates, 40 lbs. pressure. External shell is shown in dotted lines to allow of the tubes being seen. The tube had formerly been placed rather higher in the boiler. The tube collapsed sideways, having become overheated from shortness of water. The boiler itself was but little disturbed.

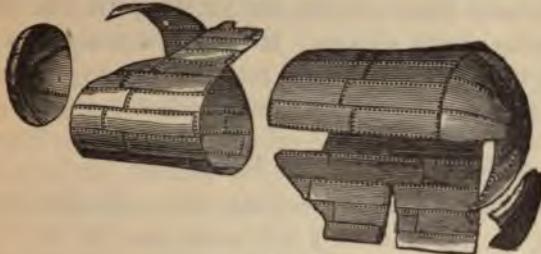
Fig. 9.

No. 10. Newcastle. (Fig. 9.) April 4th. 1 killed, 4 injured.

One of four. Plain Cylinder, 28ft. long, 6ft. diameter, $\frac{3}{8}$ inch plates, 30 lbs. pressure. The boiler was much torn and scattered, and much damage was done. The plates were improperly arranged longitudinally. The boiler gave way at a patch lately put on, and had become so deteriorated by nearly 30 years' wear, that it was unable to bear the usual pressure.

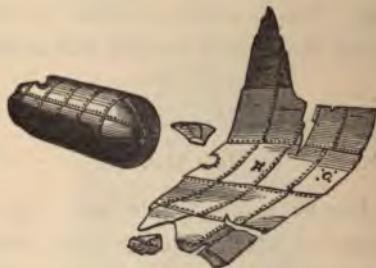
Fig. 16.

No. 30. *Bilston.* (Fig. 16.) August 17th. 1 killed.

One of two. Plain Cylinder, 30ft. long, 5ft. diameter, $\frac{3}{8}$ inch plates, 46 lbs. pressure. The boiler gave way on the side where the plates were overheated by the water being too low, and the front part of the shell was flattened out and thrown some distance to the rear, as its course was influenced by its remaining attached to the rest of the boiler as by a hinge; while the front end was rent into several pieces, and the back end was thrown also to the rear and rolled down a declivity into a stream.

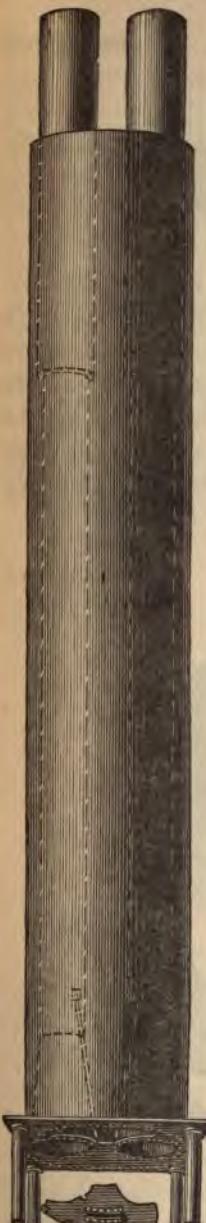
No. 31. *Liverpool.* (Fig. 17.) August 20th.
7 killed, 5 injured.

Two Furnace Chimney Boiler, 42ft. 4in. high, 6ft. 9in. diameter, $\frac{1}{2}$ inch plates, 50 lbs. pressure. Nearly half the bottom plate was blown out, and the issuing contents found their way into the furnace and increased the damage. The line of rupture near where it joined the shell was corroded almost to a knife edge, which so reduced its strength as to make it unable to bear the usual working pressure of steam, in addition to that of the column of water in the boiler.

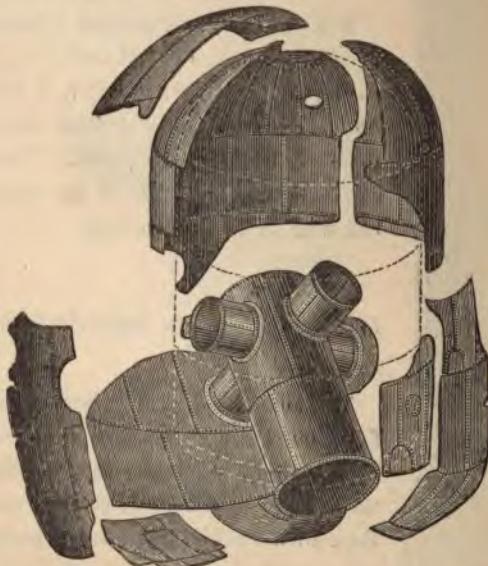
Fig. 19.

No. 35. Moxley. (Fig. 19.) September 28th. 13 killed, 2 injured.

One of four. Four Furnace Upright, 22ft. high, 10ft. 6in.

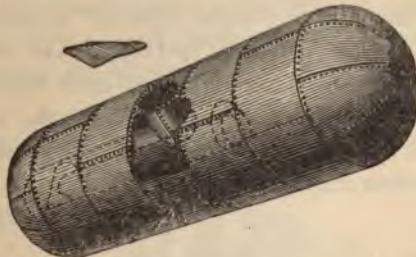
Fig. 20.

No. 37. Elsecar. (Fig. 20.) October 2nd.

One of four. Two Furnace Upright, 21ft. high, 7ft. diameter, $\frac{7}{16}$ inch plates, 58 lbs. pressure. A large piece of plate was blown out of the side of the boiler, and the reaction of the issuing contents threw the boiler over on to its side. The plate was said to be overheated from shortness of water, but as the centre tubes were uninjured, the ruptured plate may have become overheated from the intense heat impinging on one place, causing so rapid a generation of steam as to prevent proper contact of water.

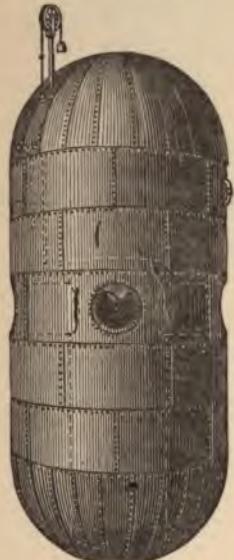
Fig. 26.

One of eight. Four Furnace Upright, 22ft. high, 9ft. diameter, $\frac{7}{8}$ inch plates, 45 lbs. pressure. The water was allowed to get so low that the shell was overheated and rent, and the side tube slightly collapsed, and the injury was not discovered until the feed water had risen up to the rupture, when it ran into the furnaces without causing any violent explosion, although cold water had been put into a red hot boiler.

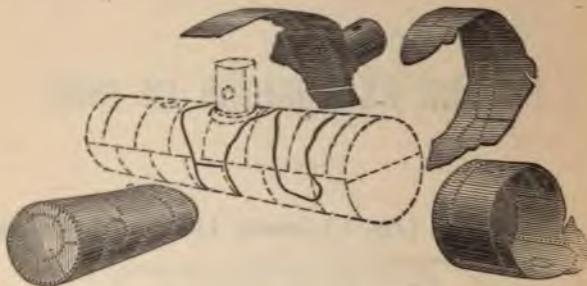
Fig. 3.

No. 3. *Greatbridge.* (Fig. 3.) January 26th. 1 killed, 1 injured.

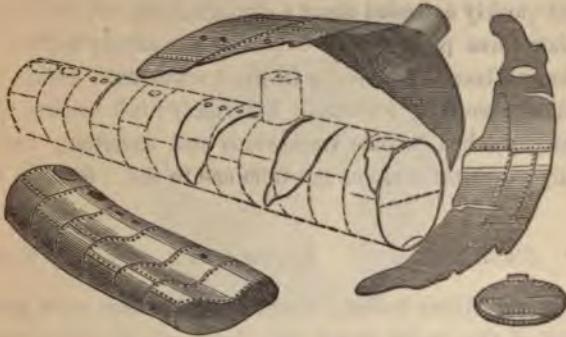
Fig. 4.

The first rent must have taken place in the bottom seams over the fire, where weakened by frequent repair.

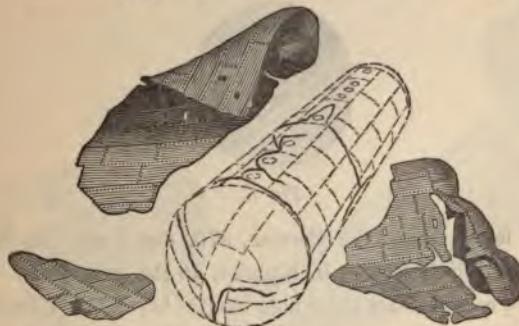
Fig. 5.

No. 5. Durham. (Fig 5.) February 2nd. 1 killed, 4 injured.

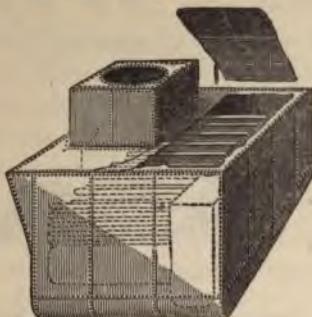
Fig. 7.

Marine, 17ft. long, and 15ft. high, $\frac{3}{8}$ inch plates, 15 lbs. pressure. The top was blown off, the plates having been extensively corroded.

The boiler had also been much weakened by altering it from a round to a flat top without sufficient stays.

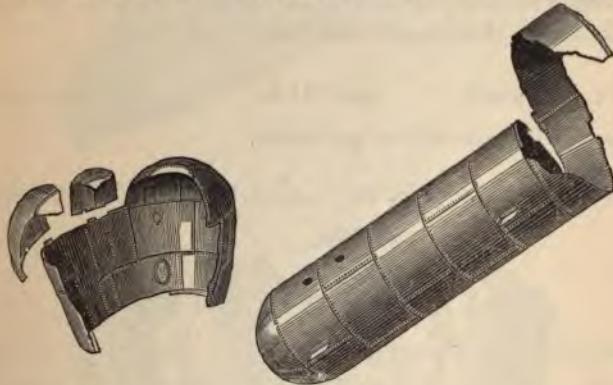
Fig. 8.

No. 10. West Bromwich. (Fig. 8.) March 9th. 3 injured.

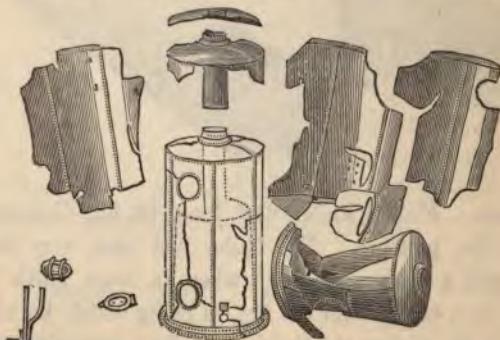
Fig. 10.

Portable Crane, 8 years old, 8ft. 3in. high, 4ft. 4in. diameter, with internal fire box, 6ft. high and 3ft. 6in. diameter, and chimney passing out at the top, $\frac{5}{16}$ inch plates, 40 lbs. pressure. The internal fire box crushed in sideways, and the shell was rent into several pieces. The attachment of the fire box to the shell was made by bending the plates, as shown in enlarged sketch, and this is not so rigid as double angle iron and had evidently strained the chimney tube. This weakness had been so increased by deep corrosion just at the bend of the plates that it had given way. The havoc and loss of life was far greater than would have been supposed possible from so small a boiler, but similar cases are mentioned in No. 43, 1868, and No. 57, 1866.

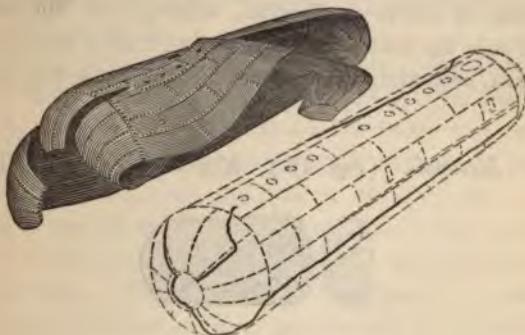
Fig. 11.

No. 15. Durham. (Fig. 11.) April 23rd. *none injured.*

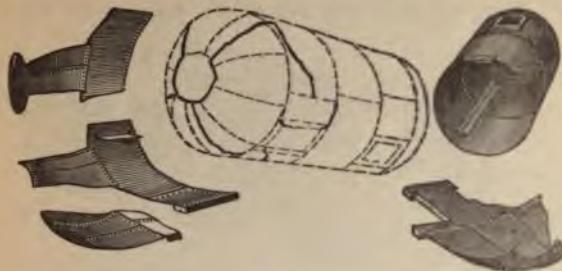
Fig. 14.

Revolving Rag boiler, 16ft. long, 6ft. diameter, $\frac{7}{8}$ in plates. There was no fire applied to the boiler itself, but it received steam through one end from other ordinary boilers at 50 lbs. pressure. There were two large rectangular manholes for putting in and taking out the rags, with cast iron frames and lids, attached by bolts with large nuts or clamps.

The explosion appeared to have taken place when, in revolving, the manlids were approaching the bottom, and the first part to give way was at one of the manholes where the frame was previously broken. The cause of the explosion was the weakness of the manholes, which were very large, and both in the same line, and the attachment of the lids was insecure, as the bolts did not go through the lids, or in any way help to compensate for the large portion of the plate cut away. The boiler was only supported at each end, and had to act as a hollow girder to bear not only its own weight but the repeated shocks of the heavy material inside falling over and over in addition to the pressure. See Nos. 41 and 63, 1866.

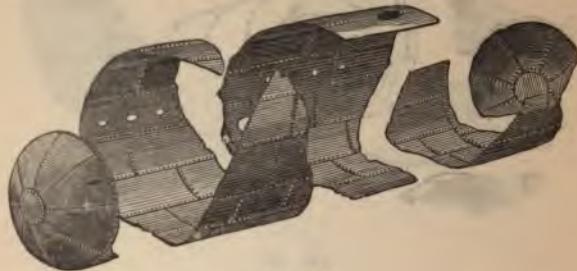
Fig. 15.

pressure. The boiler gave way at one of the long straight seams near the bottom, and rent into five pieces, which were scattered to

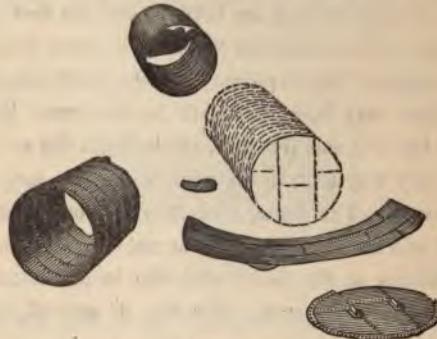
Fig. 16.

No. 21. *South Wales.* (Fig. 16.) May 31st. 5 killed, 4 injured.

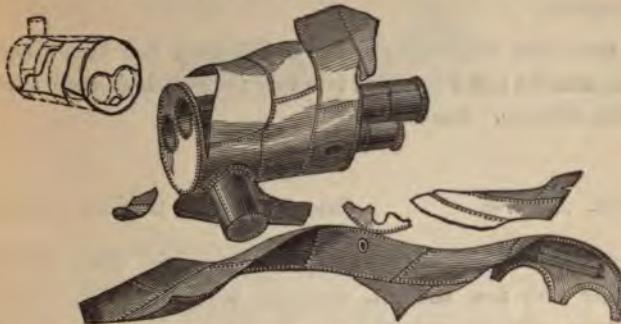
Fig. 17.

No. 22. *Bingley.* (Fig. 17.) June 9th. 15 killed, 33 injured.

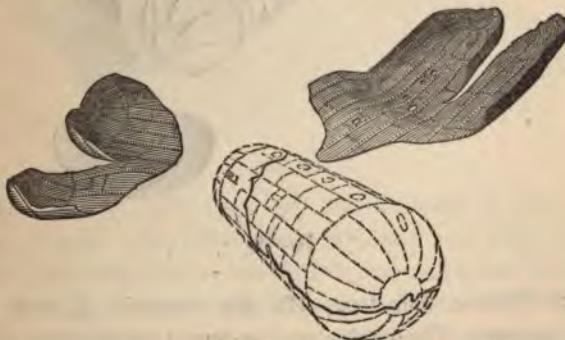
Fig. 18.

One of three. Plain Cylinder, with plates arranged lengthways,

A seam gave way over the fire where there had been frequent repair, and the boiler was rent into two pieces, which were thrown to some distance. See No. 59.

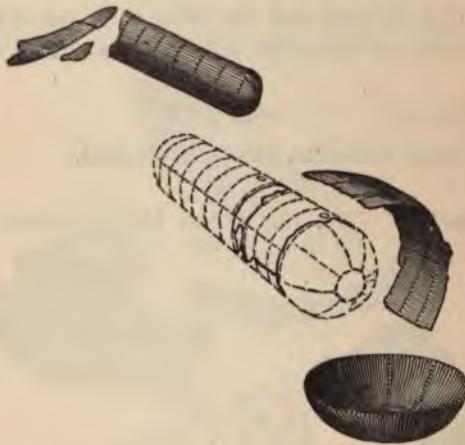
Fig. 19.

No. 26. *Nuneaton.* (Fig. 19.) July 5th. 3 injured.

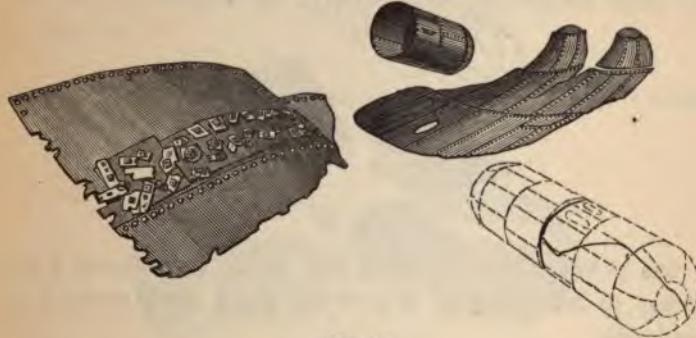
Fig. 21.

No. 29. Kidderminster. (Fig. 21.) July 16th. 1 killed, 4 injured.

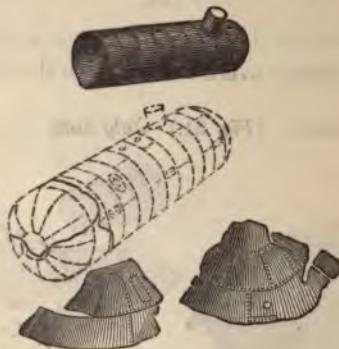
Fig. 22.

One of two. Plain Cylinder, 32ft. long, 5ft. diameter, $\frac{3}{8}$ inch plates, 40 lbs. pressure. It gave way where deeply corroded on the inside.

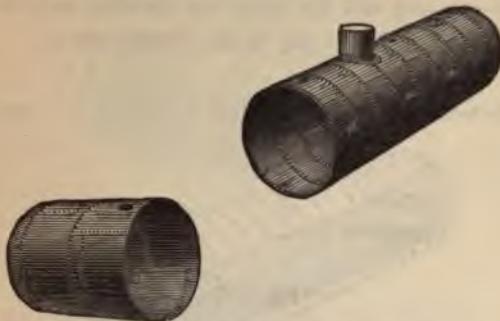
Fig. 23.

rent was an original one, and no doubt was ripped as the others had

been before repair, and that this rip extended from hole to hole until a rupture at the ordinary pressure was the result.

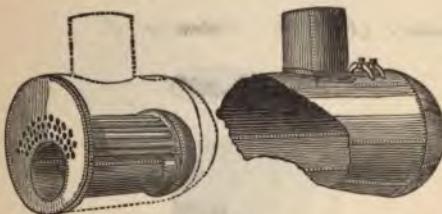
Fig. 24.

Marine, 8ft. long, 5ft. 6in. diameter, $\frac{3}{8}$ inch plates, 80 lbs. pressure. The flat front end gave way at the angle iron all round, allowing the front with tubes attached, and the shell to be thrown in opposite directions.

very defective and insufficient, and the angle iron was bad and not welded into one ring, and the boiler was therefore unfit to bear the ordinary pressure, and gave way at the weakest place.

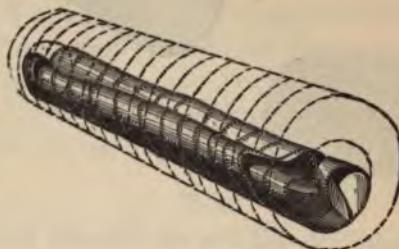
Fig. 25.

One tube Cornish, 32ft. long, 6ft. 6in. diameter. Tube 4ft. diameter, $\frac{7}{16}$ inch plates, 40 to 50 lbs. pressure. There was no steam guage.

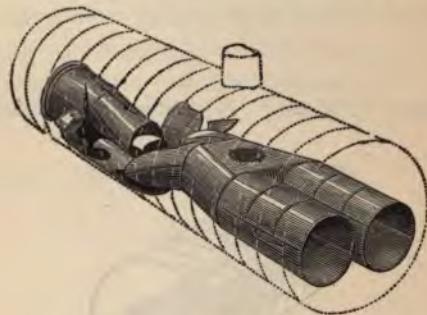
Fig. 30.

Breeches Tube, 13 years old, 30ft. long, 7ft. diameter. Furnace tube 2ft. 10in. diameter. Main tube 3ft. 5 $\frac{1}{2}$ in. diameter, and originally made to work at 20 lbs. pressure, but working lately at 45 lbs. The main tube collapsed. The boiler was not adapted for the pressure at which it was worked, and the tube was much weakened by the overheating caused by a thick incrustation of scale, and was not strengthened by any rings or stays, and was of very weak construction as the plates were arranged lengthways.

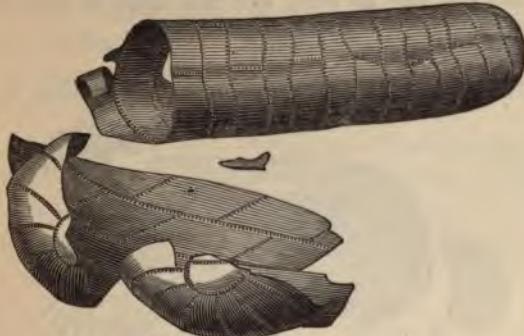
Fig. 31.

One of two, 20 years old. Plain Cylinder, 36ft. long, 6ft. 6in. diameter, $\frac{9}{16}$ inch plates, 35 lbs. pressure.

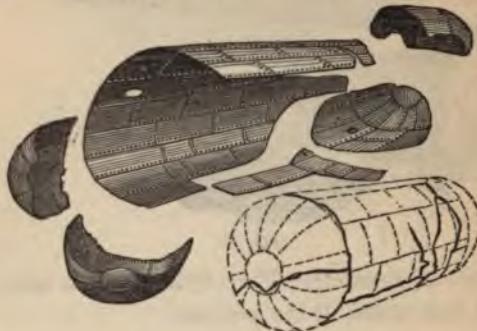
Fig. 33.

Fig. 33, No. 47, 1869, where two tubes were taken out, and Fig. 34, No. 42, 1867, where one tube was taken out. One of the most frequent and serious causes of loss of strength is the repairing of externally fired boilers. Not only are the patches sometimes

Plain Cylinder, with plates arranged lengthways, 29ft. long, 6ft. diameter, $\frac{3}{8}$ inch plates, 25 lbs. pressure.

The frequent repair had reduced the strength until unequal to bear the ordinary pressure. See No. 59.

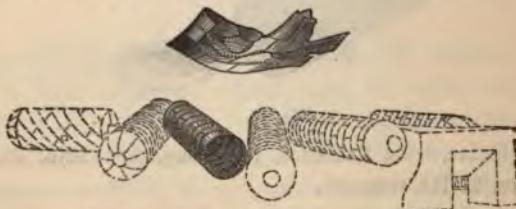
Fig. 34.

One of eight, 15 years old. Plain Cylinder, 40ft. long, 6ft.

The treacherousness and uncertainty of boilers with one patch over another has often been pointed out, as in Nos. 3, 4, 10, and 32.

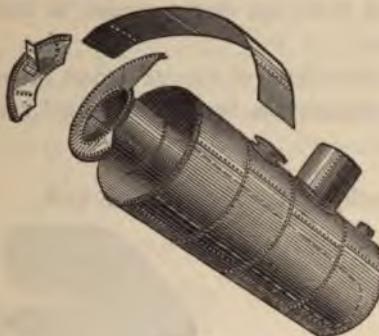
Fig. 35.

only bolted on in a temporary manner, as in Fig. 35, No. 29, 1869, but even where they are riveted on there is an entire want of bond or crossed joint, as in the case of the exploded boilers shown in

One tube Cornish, 14ft. 6in. long, 5ft. diameter. Tube 2ft. 10in. diameter, $\frac{7}{16}$ inch plates, 40 lbs. pressure usually, and sometimes 60 lbs. One ring of plates was blown out of shell.

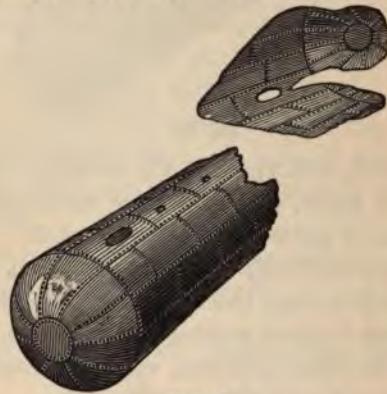
Fig. 37.

One of six. Plain Cylinder, with plates arranged lengthways, 40ft. long, 5ft. 3in. diameter, 40 lbs. pressure.

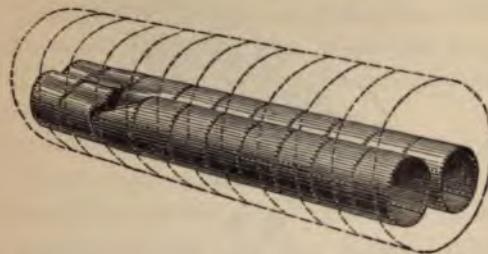
Fig. 38.

One of eight. Two tube Cornish, 30ft. long, 7ft. 4in. diameter.
Tube 2ft. 11in. diameter, $\frac{3}{8}$ inch plates, 50 lbs. pressure.

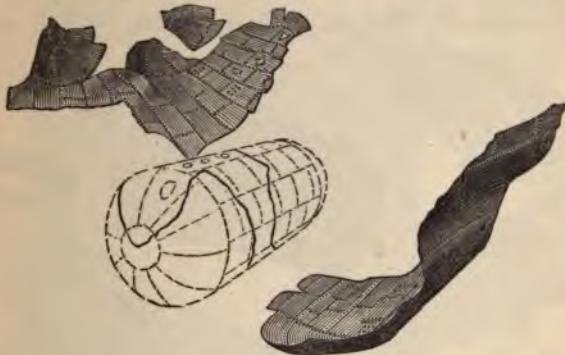
Fig. 39.

No. 50. Durham. (Fig. 39.) November 2nd. 1 injured.

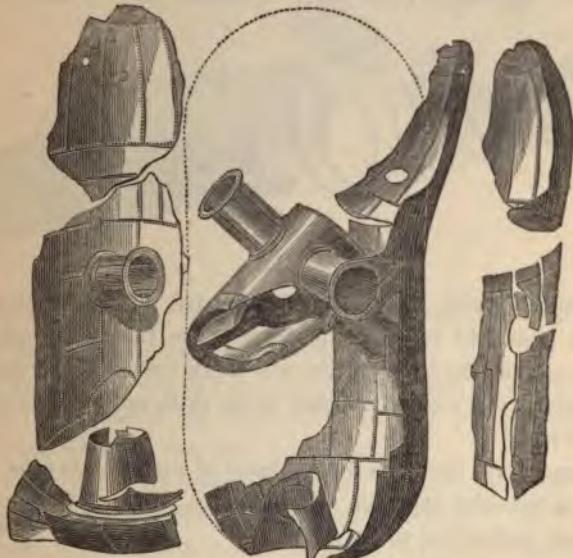
Fig. 42.

No. 53. Bilston. (Fig. 42.) December 3rd. 8 killed, 1 injured.

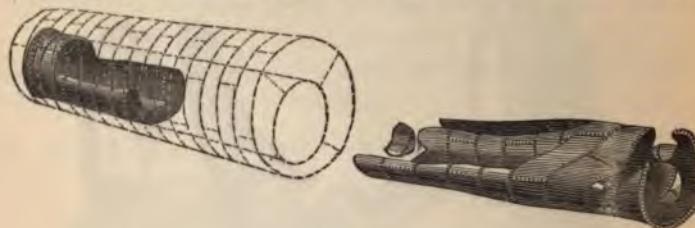
Fig. 43.

No. 54. Cornwall. (Fig. 43.) December 6th. none injured.

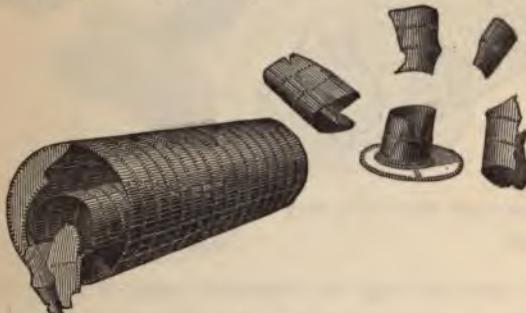
Fig. 45.

One tube Cornish, 32ft. long, 6ft 6in. diameter. Tube 4ft. diameter, $\frac{2}{3}$ inch plates, 60 lbs. pressure.

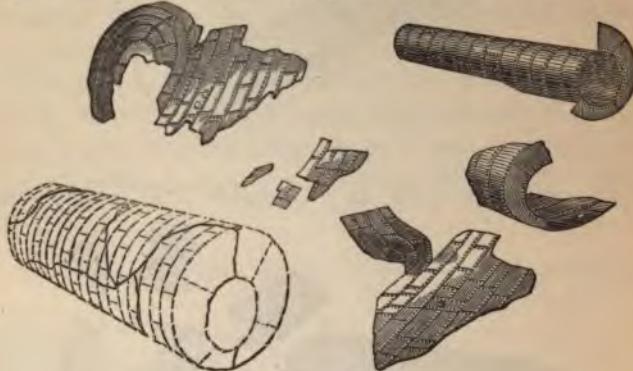
Fig. 46.

The shell was rent into several pieces, which were scattered to wide distances. The tube was also thrown to a great distance, but was uninjured. The boiler was 36 years old. The shell was very badly corroded, and temporarily repaired with screw patches to stop

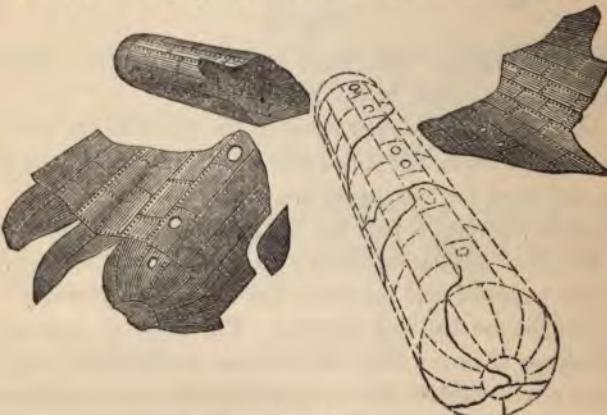
Fig. 47.

No. 59. Durham. (Fig. 47.) December 29th. 2 killed, 1 injured

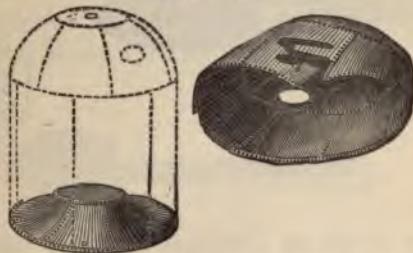
Tar Still, 10ft. high, 7ft. diameter, with round top and domed bottom, $\frac{3}{8}$ inch plates, and not intended to work at any pressure. The vapour passing away became congealed, and stopped up the small exit pipe, and pressure accumulated sufficiently to burst the weak shaped vessel.

The bottom came completely out and was left upon the fire, while the top ascended to a great height and fell a long distance away. The loss of life was owing to the material igniting and suffocating those who were thrown down by the explosion.

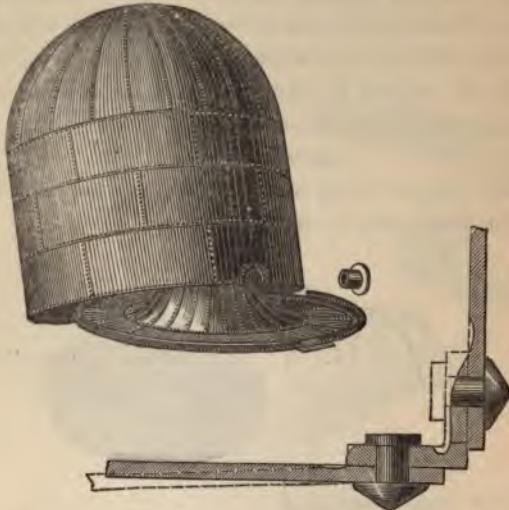
It was supposed that the intense frost, during a long stoppage for holidays, had caused the worm to be stopped up and pressure to

accumulate, as in the one previously described. But it is perhaps more probable that the vessel gave way because it was corroded so thin in so important a part as the angle iron. The explosion was very slight, the damage and loss of life being from the fierce fire which immediately succeeded it

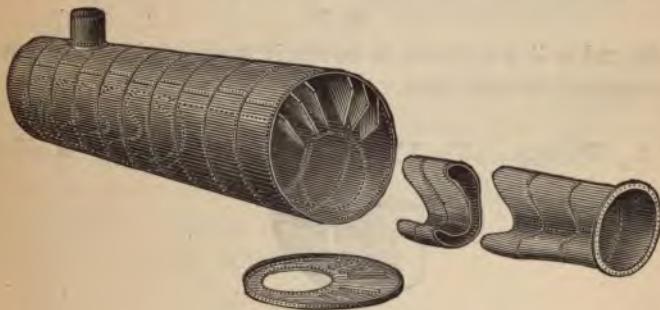
Fig. 1.

One of five. Cornish, 13 years old, 30ft. long, 6ft. 6in. diameter. Tube 3ft. 3in. diameter, $\frac{3}{8}$ inch plates, 30 lbs. pressure. Tube collapsed sideways from weakness, and the front part and the front plate were blown out, carrying the attendants into a deep and swollen river which ran close in front of boilers.

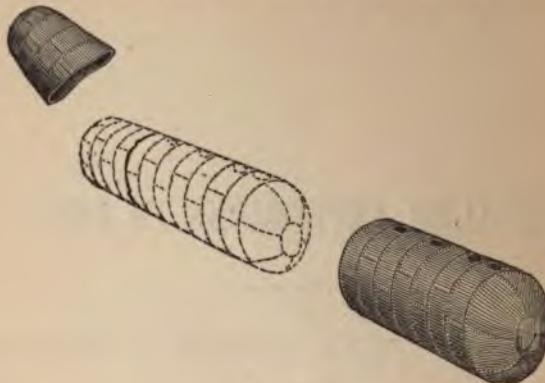
Fig. 2.

back end 150 yards to the rear, carrying away the stack. It had been badly repaired with bolted patches which had hastened cor-

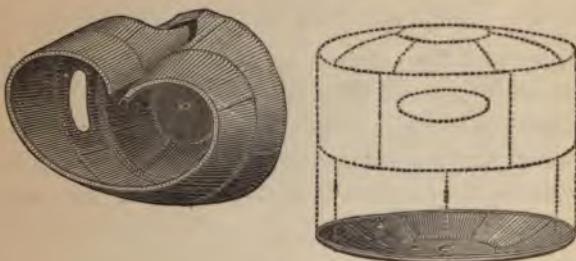
Fig. 5.

No. 5. Sheffield. (Fig. 5.) February 8th. 2 killed, 6 injured.

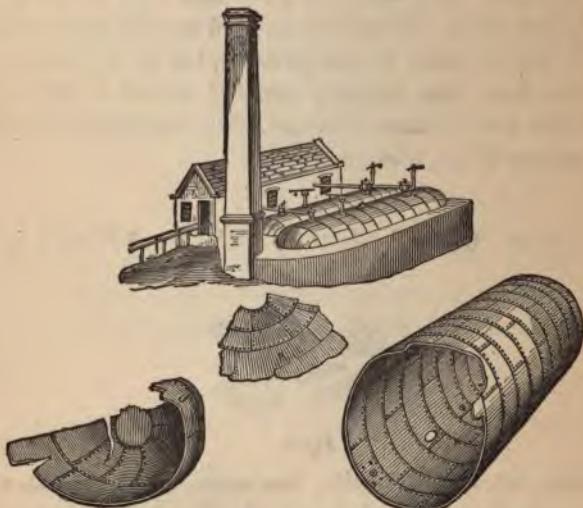
Fig. 8.

No. 8. *Walsall.* (Fig. 8.) February 19th. none injured.

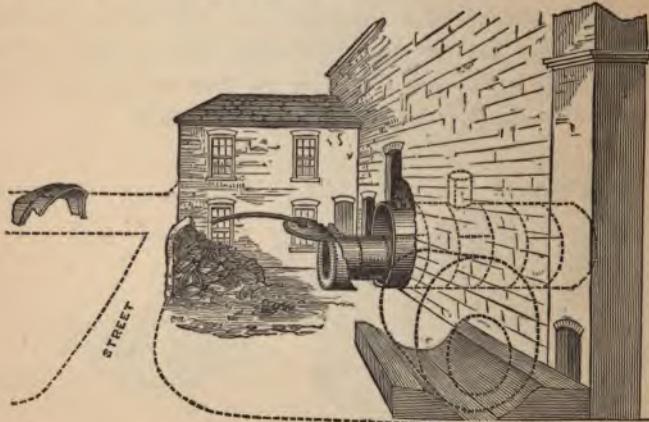
Fig. 12.

No. 12. *Portsmouth.* (Fig. 12.) March 29th. 3 killed, 1 injured.

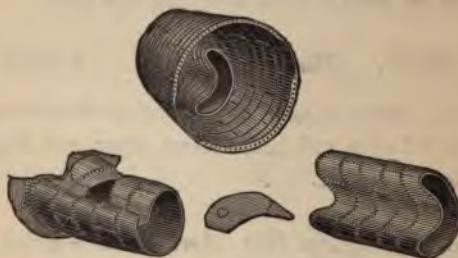
Fig. 14.

One of two. Cornish, very old, 34ft. long, 6ft. diameter. Tube 3ft. 10in. diameter, $\frac{3}{8}$ inch plates, 50 lbs. pressure. The tube collapsed and the front part was blown out, and the boiler was forced back a little. It was said to have been short of water, but the weakness of a tube of such large diameter was most likely the true cause.

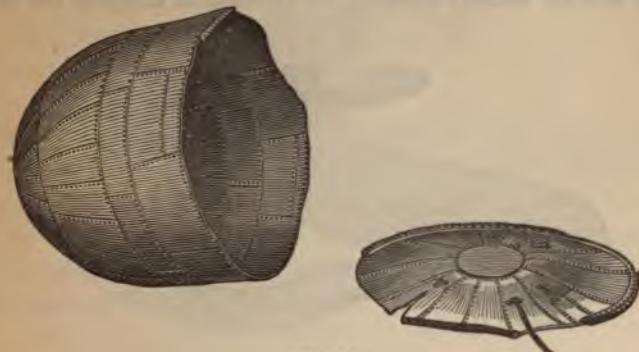
Fig. 15.

to $\frac{1}{2}$ inch, and temporarily repaired with screw patches, and was so reduced in strength that it gave way at the ordinary pressure.

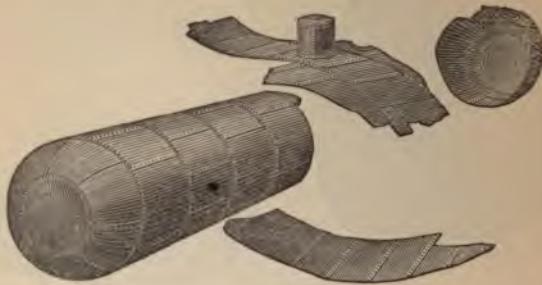
Fig. 17.

diameter, $\frac{7}{16}$ inch plates, 45 lbs. pressure. Gave way by the rent of a ripped seam over the fire, which had been repeatedly temporarily patched without restoring the strength or stopping the rip.

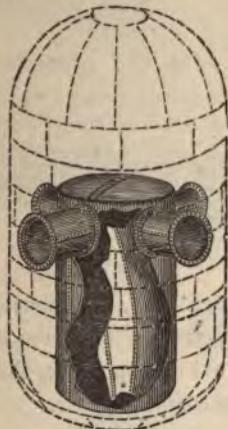
Fig. 20.

One of three. Four Furnace Upright, 12 years old, 17ft. 6in. high, 9ft. diameter. Centre tube 5ft. 9in. diameter, $\frac{3}{8}$ inch plates, 40 lbs. pressure. The centre tube was much corroded on the inside and collapsed inwards from consequent weakness, allowing the contents to issue at the bottom of the boiler, and the reaction sent the whole boiler high up into the air, and on to a roof causing great damage.

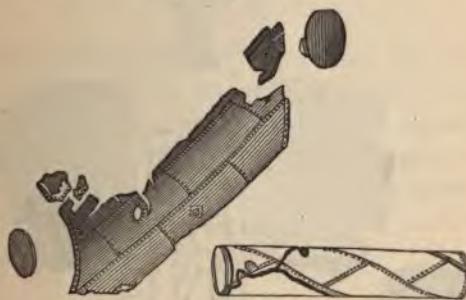
Fig. 25.

Ten years old. Plain cylinder, with flat ends, 10ft. long, 2ft. diameter, diagonal seams, $\frac{1}{4}$ inch plates, 25 lbs. pressure. The

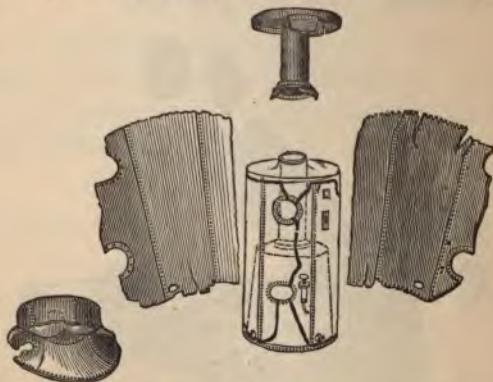
Fig. 27.

No. 31. *Glasgow.* (Fig. 27.) June 17th. none injured.

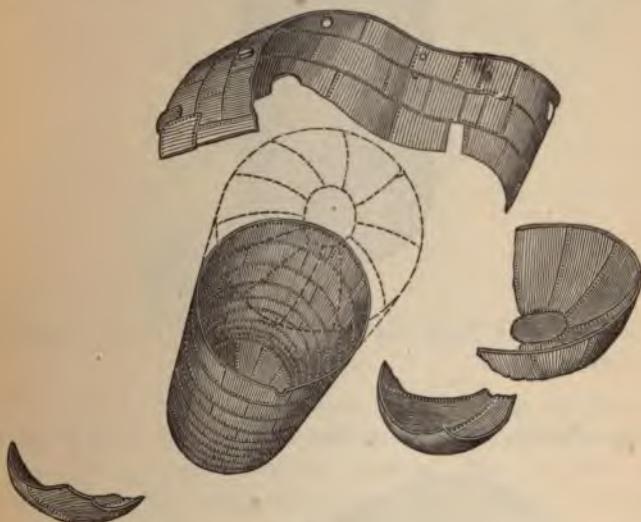
Fig. 28.

No. 32. Bilston. (Fig. 28.) June 21st. 2 killed, 6 injured.

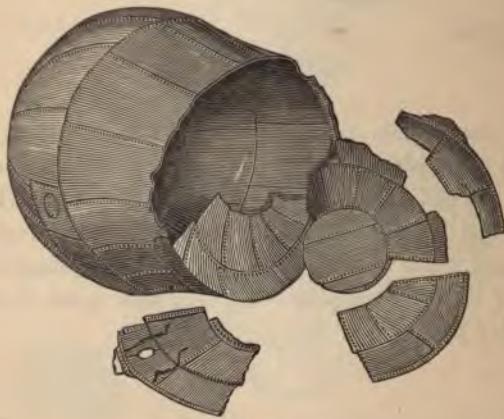
Fig. 30.

One of two. Balloon, 34 years old, 12ft. diameter, 10ft. high,

$\frac{3}{8}$ inch plates, 7 lbs. pressure. There were no stays, and the boiler was of very weak shape, and as the boiler it worked with was loaded to 15 lbs., it is presumed this also was exposed to that pressure, and burst in consequence. It gave way at the angle at front over the fire, and was thrown over the engine house.

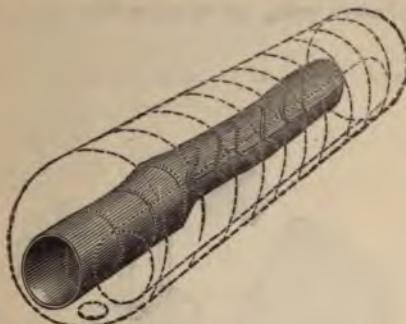
Fig. 31.

One of four. Galloway, 4 years old, 32ft. long, 8ft. diameter, $\frac{17}{16}$ inch plates. Tube 2ft. 10in. diameter, originally intended for 40 lbs., but worked at 65 lbs. pressure. The left hand tube collapsed sideways, having been very much weakened by internal corrosion.

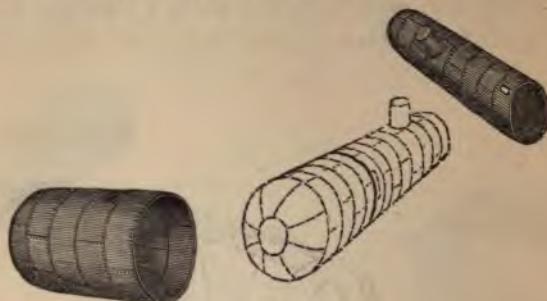
Fig. 35.

seam rip, caused by bad repair, had so far weakened it that it was

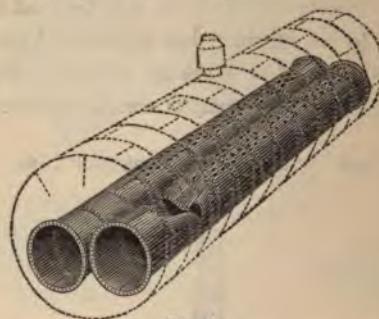
Fig. 36.

Lancashire, 2 years old, 31ft. long, 7ft. diameter, tube 2ft. 10in. diameter, with 56 Field tubes in each, $\frac{3}{8}$ inch plates, 45 lbs. pressure. The right hand tube collapsed and ruptured from softening of plates through shortness of water. The fire was blown out and set the premises on fire and much damage was done.

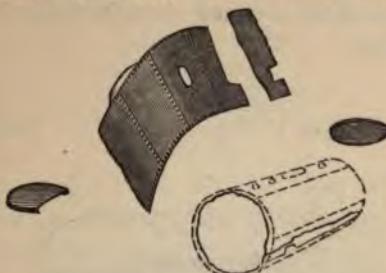
Fig. 37.

Plain Cylinder, 6ft. 6in. long, 3ft. 6in. diameter, $\frac{3}{8}$ inch plates, 80 lbs. pressure. The plates were corroded both inside and out, and in some places reduced to less than $\frac{1}{16}$ inch in thickness, and it was quite unfit to bear the ordinary pressure. The damage to the surrounding property was very great although the boiler was so small. The shell of the boiler was thrown across a street into an upper room of the house opposite.

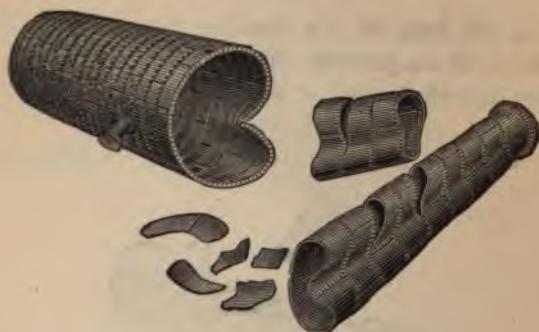
Fig. 44.

One of three. Cornish, 12 years old, 36ft. long, 6ft. diameter, tube 3ft. 9in. diameter, $\frac{3}{8}$ inch plates, 38 lbs. pressure. The tube collapsed from end to end, the front and central parts being blown out. The shell and back of tube were thrown in one piece to the rear, and much damage was done. It was supposed to have been short of water, because the tube had collapsed, but it is more likely it collapsed because of its weakness without strengthening rings. A tube in this boiler collapsed in a similar way about 5 years previously.

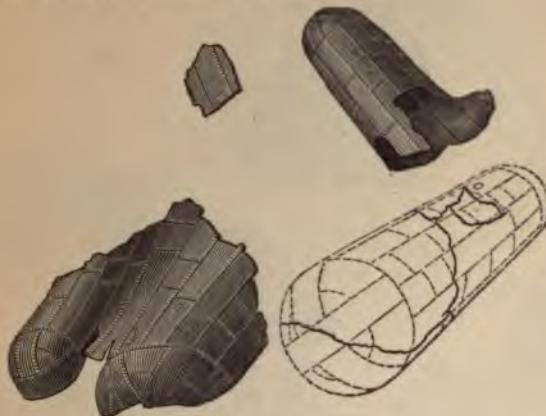
Fig. 45.

straight seamed boilers has often been pointed out. See No. 41, and many examples in former years.

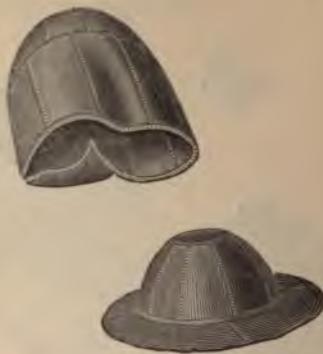
Fig. 47.

One of two. Balloon, used for evaporating only, nearly new, 9ft. high, and 9ft. diameter, $\frac{1}{2}$ inch plates, not usually worked at any pressure. The top was thrown 60 yards away, and the bottom left on furnace. The boiler was temporarily exposed to pressure which it was too weak a shape to bear.

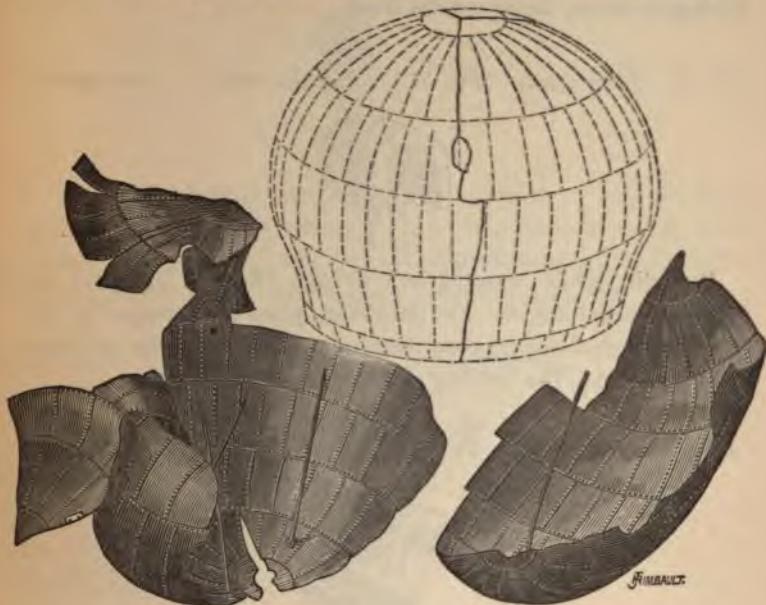
Fig. 49.

One of two. Balloon, 30 years old, 15ft. diameter, $\frac{3}{8}$ inch plates, worked at 20 lbs. pressure. It rent in two and threw down the engine house and chimney. The boiler was not intended to work at more than 5 lbs. pressure, and was quite unable to bear the extra pressure to which it was exposed.

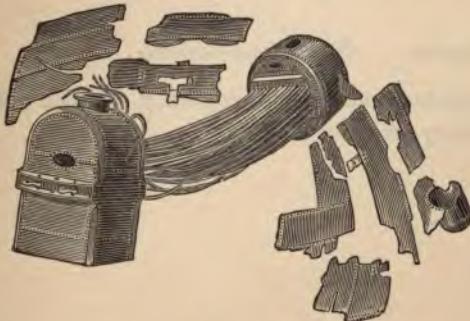
Fig. 56.

No. 67. Northallerton. (Fig. 56.) December 29th. 1 injured.

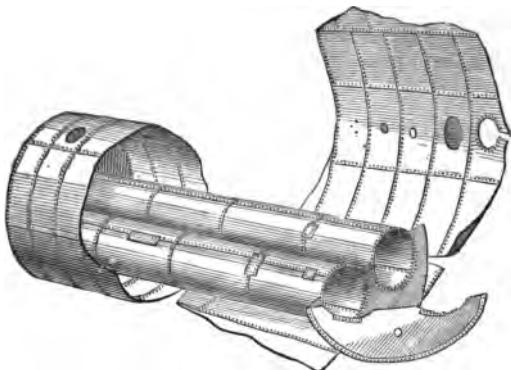
Fig. 4.

No. 5. Stirchley. (Fig. 4.) January 9th. 1 killed, 4 injured.

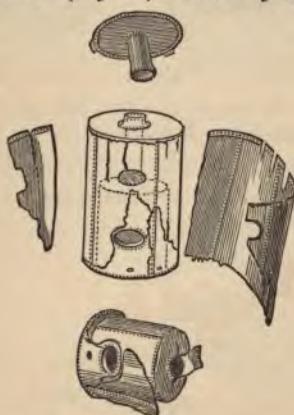
Fig. 8.

One of two, 1 year old. Portable upright, 6ft. high, 3ft. diameter,

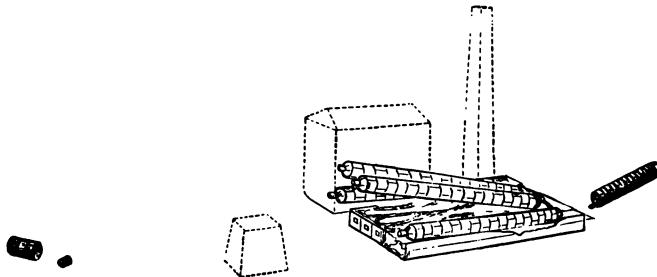
Fig. 12.

No. 22. *Brigg.* (Fig. 12.) March 17th. 1 killed, 1 injured.

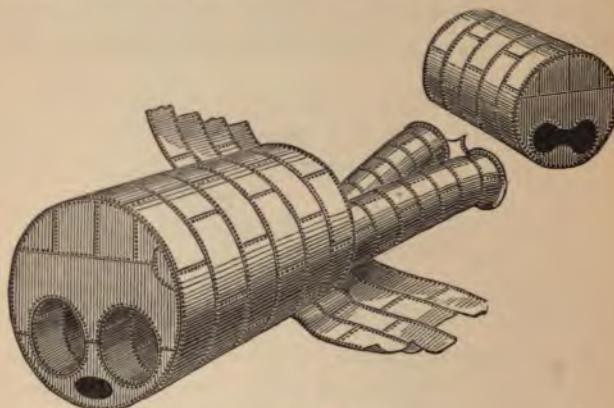
Fig. 13.

No. 23. S. Wales. (Fig. 13.) March 18th. *none injured.*

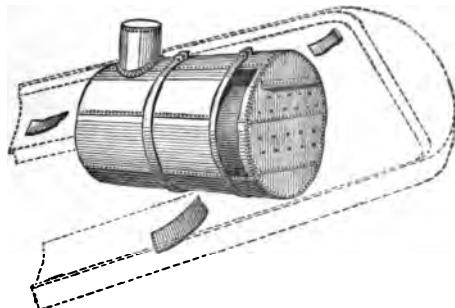
Fig. 15.

Marine, 7 years old, 9ft. 2in. long, 6ft. 1in. diameter. Furnace tube 2ft. diameter, and 3 inch small tubes, $\frac{1}{8}$ inch plates, 81 lbs. pressure. There were two bands as clips round the outside of boiler. Gave way at a seam where some new bottom plates had been inserted, and where the old plate was so thinned by internal corrosion as to be unable to bear the usual pressure. A small plate was blown out and shattered into three pieces, and the boiler was turned end for end.

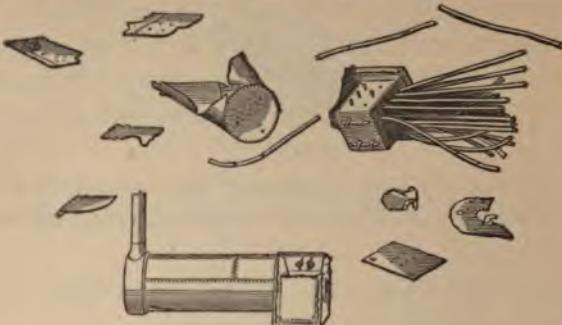
Fig. 16.

No. 27. *Leamington.* (Fig. 16.) May 18th. 1 killed, 2 injured.

Portable multitubular, 9 years old, 8ft. 6in. long, 2ft. 6in. diameter, $\frac{5}{16}$ inch plates, 50 lbs. pressure. The safety valve was fastened down by a nail (A) between the lever and the cover, and in consequence the pressure accumulated to more than the boiler could bear, and it was rent into many pieces, which were widely scattered.

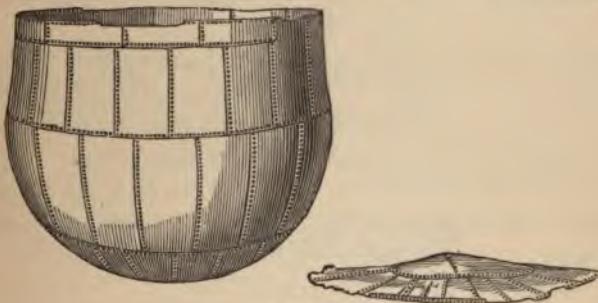
Fig. 18.

No. 31. Oakengates. (Fig. 18.) June 6th.

One of two, 20 years old. Balloon, 14ft. diameter, $\frac{3}{8}$ inch plates, 6 lbs. pressure. The pressure was allowed to far exceed the proper height during a temporary stoppage of the engine, and the bottom was rent off, and the top thrown some distance, but very little damage was done.

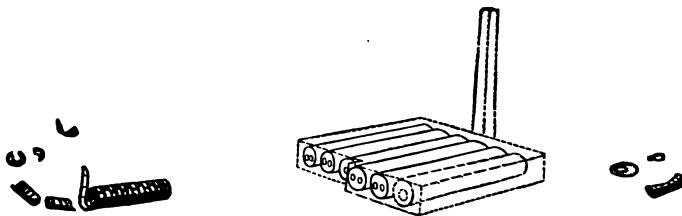
Fig. 20.

No. 33. *Tunstal.* (Fig. 20). June 28th. 8 killed, 20 injured.

Cornish, 43ft. long, 6ft. 6in. diameter, $\frac{7}{16}$ inch plates. Tube 3ft. diameter, $\frac{2}{3}$ inch plates, 50 lbs. pressure. The tube collapsed sideways from end to end through weakness, being without strengthening hoops, and with continuous longitudinal seams. The back end and part of the tube were thrown to the rear, and the rest of the boiler was thrown to the front, and separated into several fragments.

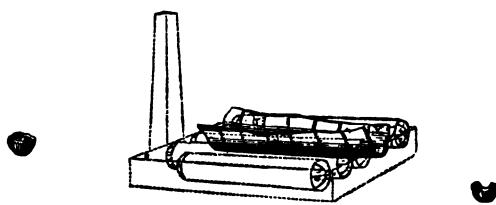
Fig. 22.

No. 37. Cumnock. (Fig. 22.) July 28th.

One of five, about 20 years old. Plain cylinder, 20ft. long, 4ft. diameter, $\frac{5}{8}$ inch plates, 45 lbs. pressure. The boiler had been much patched and altered, and was in very poor condition, and unfit to bear safely the ordinary pressure. Rupture commenced near the feed pipe, and ran along one side and then round each end, both of which were liberated and thrown far away, the barrel of the boiler spreading out on to the neighbouring boilers, one of which was much injured.

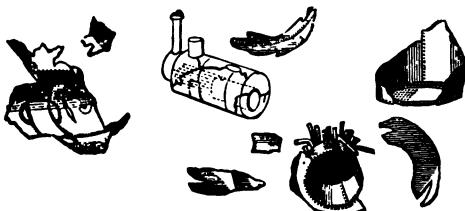
Fig. 23.

Multitubular, 10 years old, 7ft. long, 3ft. 6in. diameter, $\frac{5}{6}$ inch plates, 50 lbs. pressure, but valve loaded to 80 lbs. Rupture commenced at the unguarded manhole, and the shell was rent in

several pieces which were much scattered. The safety valve was defective, and the boiler had been much weakened by many patches,

and was in poor condition and unable to bear the pressure at which it was worked at the time of explosion.

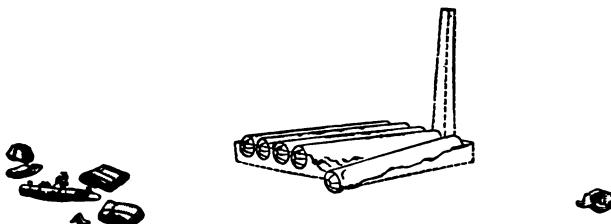
Fig. 27.

No. 45. *Gresley.* (Fig. 27.) September 2nd.

One of six, 2 years old. Plain cylinder, 40ft. long, 5ft. diameter, $\frac{3}{8}$ inch plates, 50 lbs. pressure. This case was peculiar, as the back part of the boiler was found a long way to the front, and the front end in the rear. An accumulation of scale caused pocket to form, and a hole to burn through the bottom over the grate, allowing the contents to issue so violently that the boiler was sent over end for end, when the front end was knocked off and thrown to the rear, and the contents then issuing more violently, the reaction sent the rest of the boiler in one piece a great distance to the front, where it fell, and was crushed nearly flat and broken into several fragments.

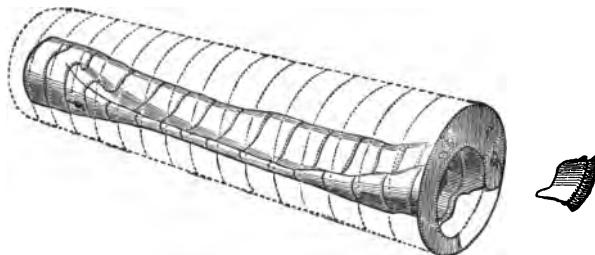
Fig. 28.

No. 46. *Cornwall.* (Fig. 28.) September 16th.

One of two, 18 years old. Cornish, 32ft. 9in. long, 6ft. 6in. diameter. Tube 4ft. diameter, $\frac{3}{8}$ inch plates, 45 lbs. pressure. The tube collapsed from end to end, dropping together like an old sack, and cracking at the edges. A small piece at the front end was blown out. The cause was supposed to be shortness of water as

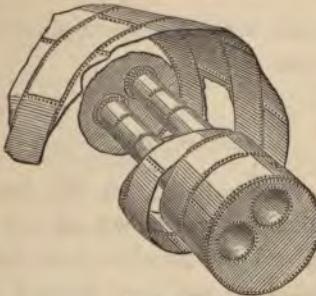
Fig. 30.

No. 48. Grindleton. (Fig. 30.) September 26th. 1 killed.

Lancashire, 3 years old, 20ft. long, 7ft. diameter. Tube 2ft. 2in. diameter, $\frac{3}{8}$ inch plates, 60 lbs. pressure. The boiler gave way at the second ring of plates from the back end, at the side where externally corroded to a knife edge, by brickwork made damp by being next the side of a hill. The rents extended round the boiler,

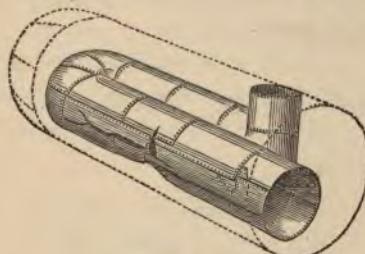
Fig. 32.

No. 55. *Bowling.* (Fig. 32.) October 30th. 1 killed, 1 injured.

One of two, 17 years old. Marine, 12ft. 7in. long, 6ft. 3in. diameter. Tube 4ft. wide, 2ft 9in. high, 16 lbs. pressure. The tube was much weakened by corrosion and screw-patching and collapsed upwards, with the slightly increased pressure of a temporary stoppage of the engine.

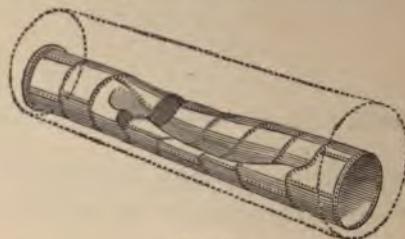
Fig. 33.

No. 57. Newcastle. (Fig. 33.) November 5th.

Cornish, 25ft. long, about 6ft. diameter. Tube 3ft. 6in. diameter, $\frac{3}{8}$ inch plates, 30 lbs. pressure. Tube collapsed from overheating through shortness of water.

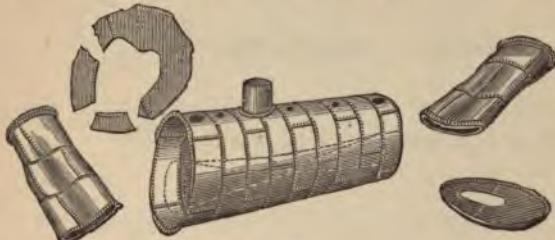
Fig. 35.

No. 59. Bilston. (Fig. 35.) November 12th. *none injured.*

One of four. Cornish, about 20 years old, 26ft. long, 6ft. 6in. diameter, $1\frac{7}{8}$ inch plates, 40 lbs. pressure. Tube 3ft. 9in. diameter had been made in two parts, joined in the centre by a narrow plate $\frac{3}{8}$ inch thick, and it collapsed at this joint, so that the top met the bottom, and thus so retarded the issue of the contents after being set in motion, that a shock was produced, which blew out an end and half the tube in opposite directions. The shell was left resting in its seat, and little damage was done to premises. The tube had much the appearance of collapse from shortness of water, but the most probable cause was that it was too weak without strengthening hoops to bear the ordinary pressure with safety.

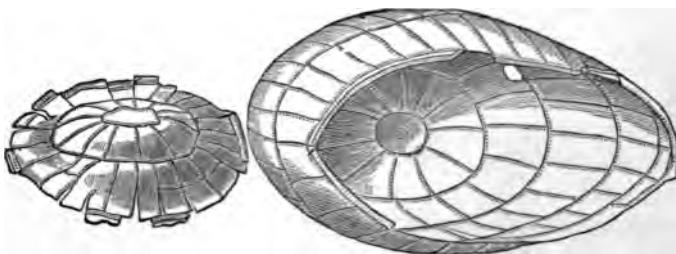
Fig. 38.

No. 65. Westbromwich. (Fig. 38.) December 28th. 1 injured.

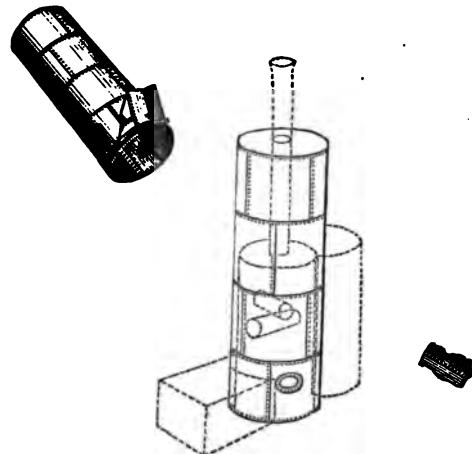
Fig. 39.

No. 66. Glasgow. (Fig. 39.) December 30th. 11 killed, 30 injured.

where attached to the fire holes and collapsed inwards, and the reaction of the issuing contents forced the boiler up some distance on

to the top of a house. The safety valve did not act properly, and the pressure appears to have accumulated to more than the boiler could bear, during a temporary stoppage of the engine.
